New timber treatment requirements

Various activities are underway in the building industry in response to weathertightness problems and some steps have now been taken. One is the recent revision of the *Acceptable Solution for B2 Durability*. A key issue in this revision has been setting minimum levels of timber treatment for selected parts of a building through reference to the (also) revised standard NZS 3602. This feature discusses some important consequences of these revisions.

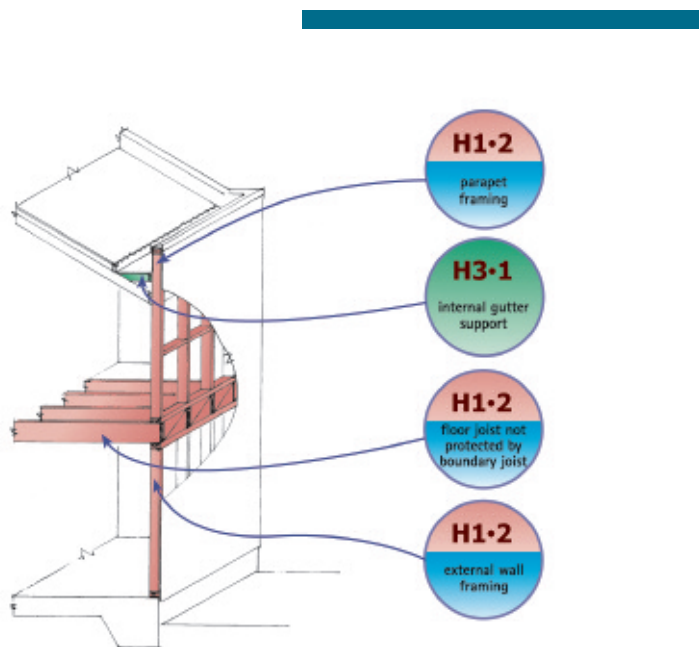
Figure 3: Joist, parapet and exterior wall.

Intermediate floor joists that have their end grain exposed to the back

of the cladding (i.e. not protected by a boundary joist) are at risk if moisture penetrates the cladding. These joists must be treated to the same hazard level as the supporting wall framing, which is the minimum H1.2. See Figure 3.
